Effect of severe hurricanes on Biorock Coral Reef Restoration Projects in Grand Turk, Turks and Caicos Islands

Abstract: Artificial reefs are often discouraged in shallow waters over concerns of storm damage to structures and surrounding habitat. Biorock coral reef restoration projects were initiated in waters around 5m deep in Grand Turk, at Oasis (October 2006) and at Governor's Beach (November 2007). Hemi-cylindrical steel modules, 6m long were used, four modules at Oasis and six at Governor's Beach. Each project has over 1200 corals transplanted from sites with high sedimentation damage, and are regularly monitored for coral growth, mortality and fish populations. Corals show immediate growth over wires used to attach corals. Growth has been measured from photographs using a software program and is faster at Governor's Beach. After hurricanes Hanna and Ike (September 2008) the Governor's Beach structure was fully standing since the waves passed straight through with little damage, the Oasis structures which were tie-wired rather than welded had one module collapse (since been replaced with a new, welded structure). Hurricane Ike was the strongest hurricane on record to hit Gra

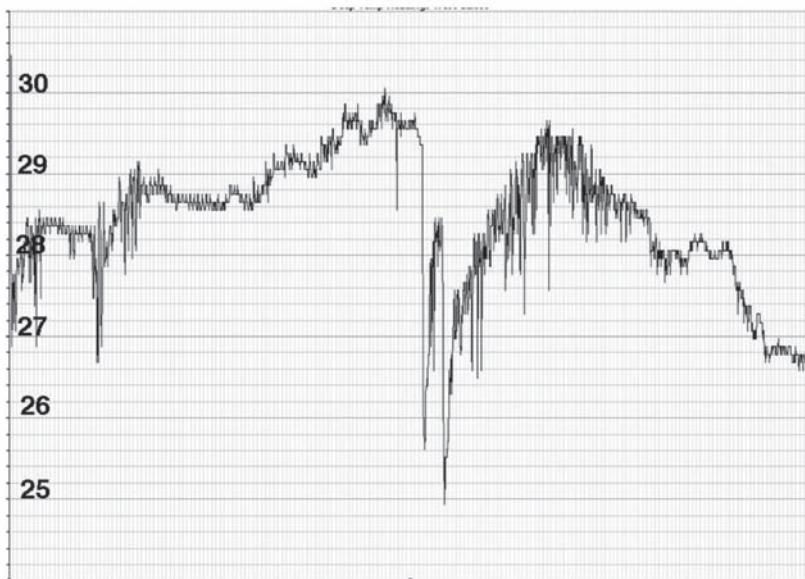
Fig. 1. Temperature records in degrees celsius from May 24 to December 9, 2008 logged at West Caicos by DECR. The first dramatic decrease marks Hurricane Hanna, the second is Hurricane Ike.

Marine impacts: Temperature and light logs: A recording datalogger measured temperature and light levels before, during, and after these hurricanes at a location 43 m deep in West Caicos. Temperatures plunged around 4°C after Hanna, rose about 2.5°C before Ike, and then dropped around 3.5°C after Ike. It took about a month to regain normal temperatures (Fig. 1). Light measurements indicated near complete light extinction at depth during the week of the hurricanes, and that fine suspended particulates kept light levels roughly one tenth of normal for the succeeding four months (Fig. 2).

Several dives were made on Biorock projects in the weeks after the hurricanes. Sedimentation was not high as expected. Although local divers reported turbidity levels were elevated and persistent in some areas of Providenciales, West Caicos, French Cay, and West Sand Spit, dives in Grand Turk after the Hurricane Ike did not show a high level of turbidity (Fig. 1).

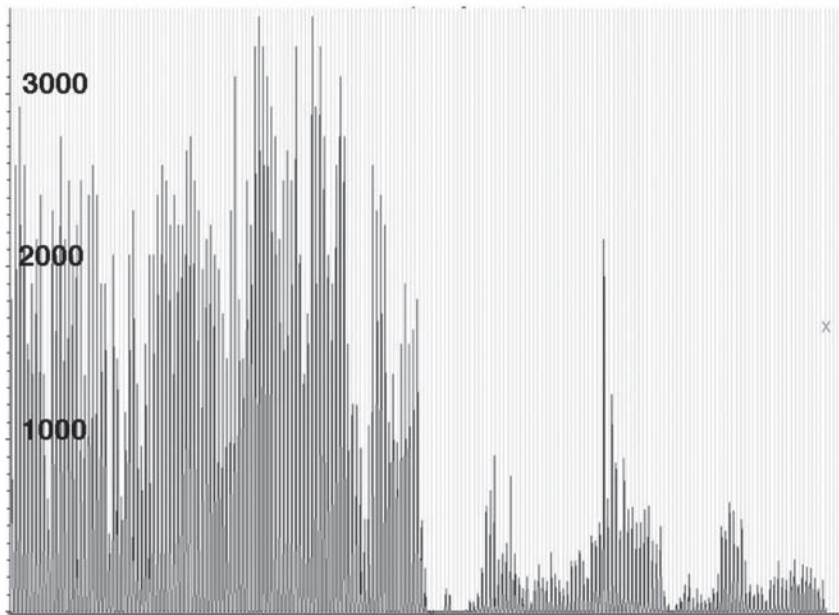
Fig. 2. Light records in lux logged from May 24 to December 9, 2008 at West Caicos by DECR. Light levels plunged after the hurricanes and remained low the rest of the year due to the residual effects of resuspended fine sediments.

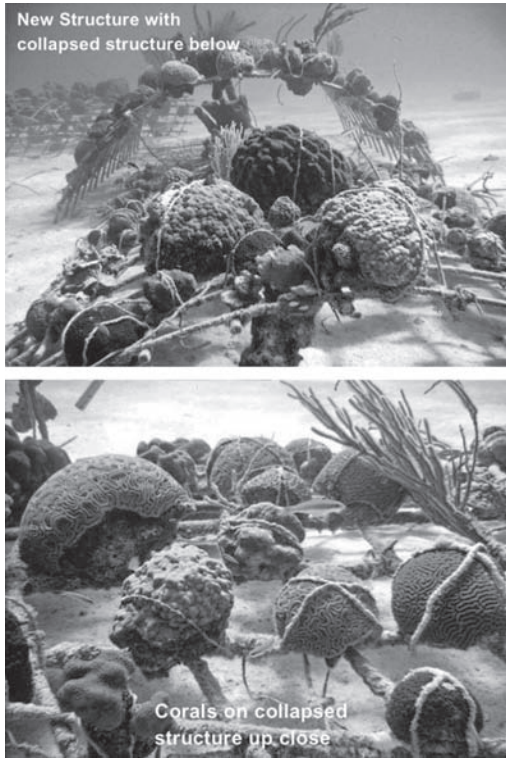
Fig. 3. Corals growing on structure, showing healthy growth. Photos by Lucy Wells.

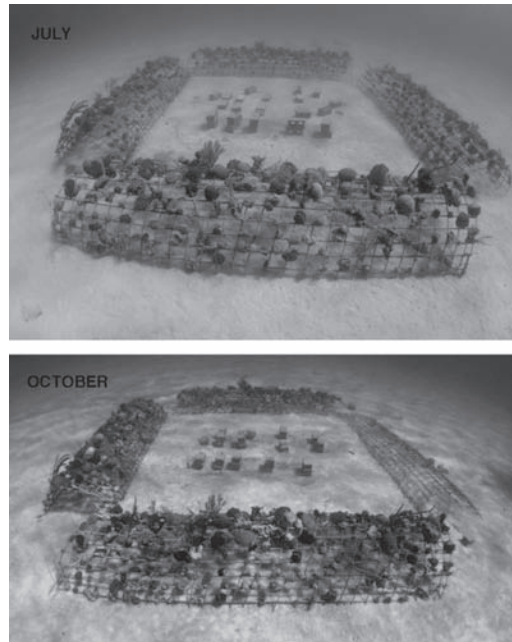
After the hurricanes the Governor's Beach structure was fully erect since the waves passed straight through with little damage. The Oasis structures, tie-wired rather than welded, had one module sag open in place (since replaced with a new, welded structure). However this structure was still intact, and when rewired, the corals continued to grow on it (Fig. 3). The projects lost about 30% to 40% of corals due to the hurricanes. Most of those lost had only been wired a few days before and had not yet attached themselves firmly. However, high coral survival and low structural damage after hurricanes indicate that Biorock reef restoration can be effective in storm-impacted areas. Photographs of both projects before and after the hurricanes are shown in Fig. 4 and Fig. 5.

Fig. 4. Oasis Projects, before and after hurricanes, in July and October 2008. Photos by Mike Reimers.

Governor's Beach structures, which shallower and closer to shore, would have been expected to have more physical wave damage, but had little or none. The Oasis structures had one module sag. These structures at Oasis had not been welded, they had simply been hand tied with binding wire. This project received very little power for the first year due to repeated breakage of the cables by dragging anchors, until the area was made a No Anchor Zone. During extended periods of no power, binding wire did not receive complete protection from rusting by the electrical current, and many binding wires rusted and fell off. Nevertheless only one of the four structures sagged. The reason for the very minor physical damage is almost certainly that these structural volumes are more than 99% water, so waves passed right through the structures with minimal drag forces. That might not have been the case had they had flat closed surfaces. The fact that these structures were severely undercharged implies that faster growing structures would have had even less damage. Accretion and coral growth could be further increased by delivering more power to the structures.

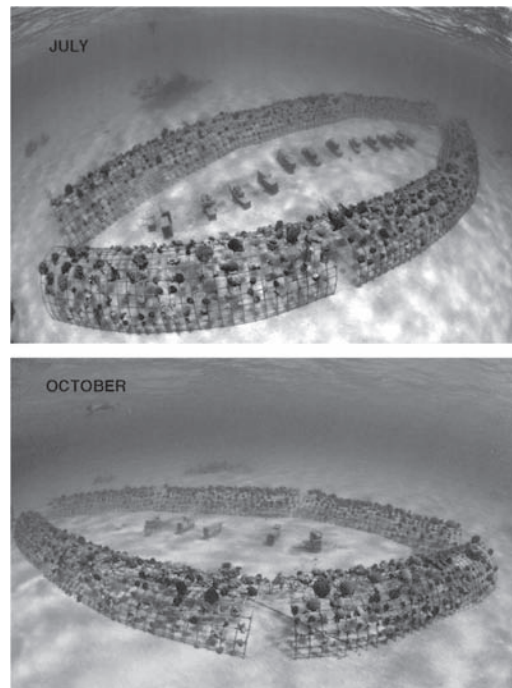
Fig. 5. Governor's Beach Projects, before and after hurricanes, in July and October 2008. Photos by Mike Reimers.
