## Transplantation of benthic species to mitigate impacts of coastal development in Jamaica

**Abstract:** Maintaining regional competitiveness and economic viability for Port Bustamante - Kingston Harbour, Jamaica, required improved accessibility to "Post Panamax" (too large to pass through the Panama Canal) container vessels. Removal of the northern portion of the shallow coral reef at Rackham's Cay, which was partially obstructing the western end of the east ship channel, was proposed. This aesthetically valuable reef was used by local fishermen and comprises part of the declared Palisadoes - Port Royal Protected Area. The proposal to transplant certain of the benthic species was advanced to mitigate loss of viable reef components. Between December 2001 and February 2002, sixty thousand items, consisting of reef building massive and branching corals; gorgonians; urchins (*Diadema* and *Tripneustes* spp.) and *Thalassia* meristems were relocated. During dredging, sedimentation rates from suspended solids in the water column were 0.003 g/cm<sup>2</sup>/day at the control site and 0.008 g/cm<sup>2</sup>/day at the dredge site. Coral cover in the relocation area increased from 15% t

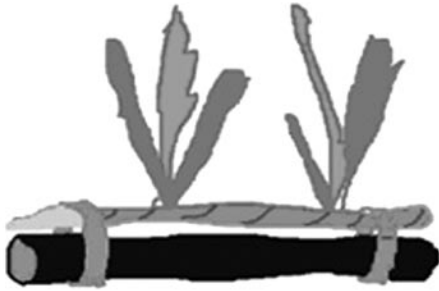
Fig. 3. Seagrass meristem unit secured to iron rebar using rubber bands.

Seagrass meristems were dug from the muddy bottom sediments with the aid of a hand operated suction dredge. They were bundled into “units” consisting of two or three meristems held to a piece of iron rebar (0.7 cm x 15 cm - construction iron) with rubber bands to act as a weight (Fig. 3). These units were placed in a second relocation area, a sandy clearing to the south west of Maiden Cay (17°54’N and 76°48.8’W) with a unit placed at each 1 m x 1 m intersection within a 30 m x 30 m area.

The pieces of rebar were buried approximately 5 cm in the sand to aid resistance to wave energy and to help maintain the upright orientation of the seagrass blades in the water column so as to facilitate growth.

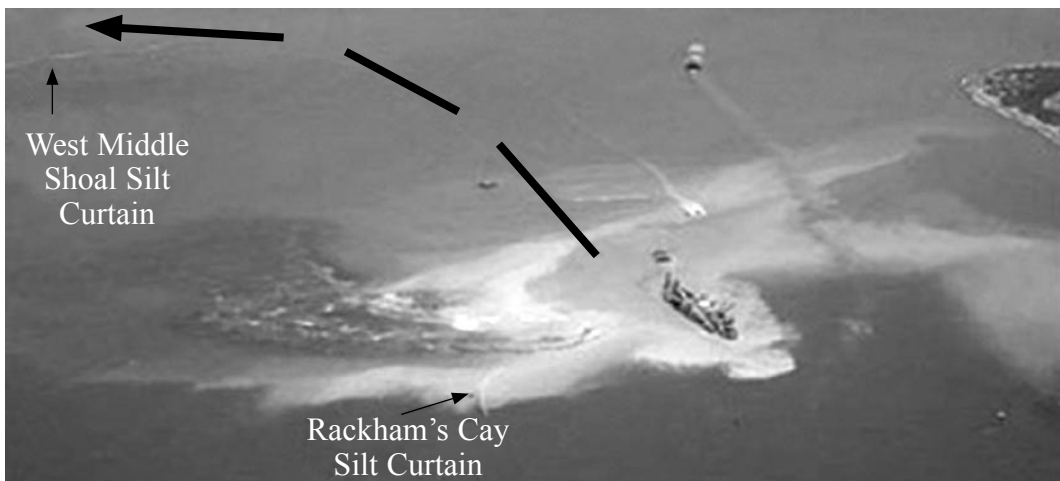
Fig. 4. Positions of silt curtains and movement of sediment plume, 14 June 2002. Red arrow: direction of plume movement three days earlier.

Aerial surveys documented the silt plumes and formed the basis of judgements regarding the placement of the silt curtains. The plume direction was determined by ambient wind and current direction which varied from day to day. Dredging took place for 18 days during the period June 8-27, 2002. During this time, general wave conditions rendered the silt curtains useless at both sites on several occasions (Fig. 4) because they were undercut by tidal driven.

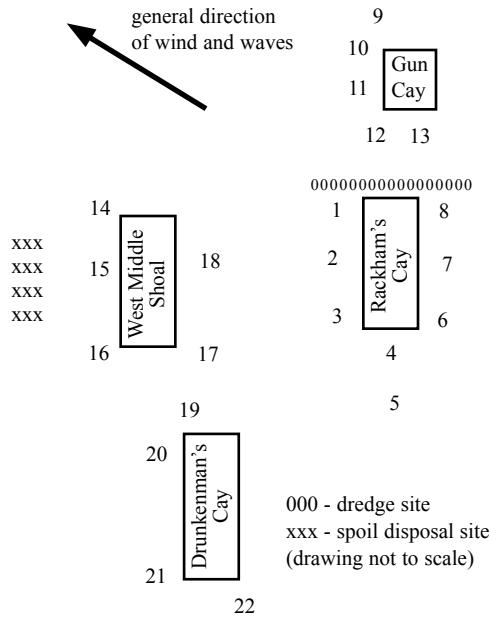
Fig. 5. Positions of sediment traps relative to dredge and dump sites and adjacent cays.

Sedimentation rates of material resuspended during dredging were determined using straight sided plastic jars (10 cm high x 8.3 cm diameter) secured to stakes and held at 50 cm and 10 cm above the substrate at four locations immediately adjacent to the dredge and dump sites and including a control site upstream of all dredging activity. This allowed the determination of the actual amount of sediment being transported in the water column (Settling Component) by the actual dredging in contrast to the amount of sediment being resuspended from bottom sediments (Bedload Component) by wave action. Sediment collection traps were placed at 3-6 m depths at Rackham's Cay, Gun Cay, West Middle Shoal and Drunkenman's Cay, the latter as the control site (Fig. 5). At six day intervals the jars were sealed at depth and brought back to the lab where the samples were filtered through a dried, pre weighed filter. After filtration, the filter paper was dried to

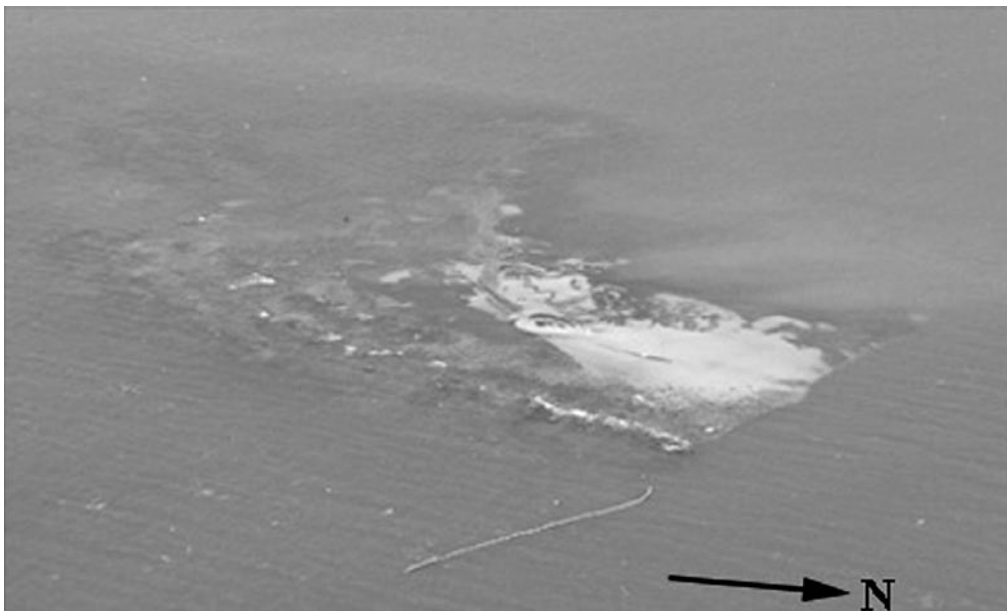
Fig. 7. Present day view of Rackham's Cay with northern tip removed.

The shape of Rackham's Cay at the end of the dredging exercise is radically different from the start of the project. An almost straight edge (Fig. 7) and vertical face along its northern border exposes the layers of partially cemented coral rubble comprising the substrate.

Beginnings of colonisation are now being seen on this cut face with gorgonians, ascidians and various encrusting sponges now being found on the exposed pieces of rubble at varying densities. Presumably these are highly dependent on the amount of surface light able to filter through the turbid channel waters to reach the particular depth on the cut face. The cut face was supposed to have a 1:1 slope. This is not evident. Two terraces (each 2-3 m wide) at 10 m and 14 m depth respectively form breaks in the face of the cut that has a slope of between ten and twenty degrees from the vertical instead of the planned forty five degrees. The long-term stability of the cut face of the Cay will need to be carefully monitored.
